As part of the City-Wide Flood Risk Assessment and Storm Outlet Review, the City of Pembroke has requested an assessment of the condition on 17 of the City’s storm sewer outfalls, complete with an inventory of the findings. After conducting the outfall assessment, Aquafor Beech reported a total of 9 outfalls in poor condition and in need of repair. The following Technical Memo provides an overview of the existing conditions of Outfall 27 as well as the Detailed Design of the proposed outfall reconstruction.

CITY WIDE FLOOD RISK ASSESSMENT AND STORM OUTLET REVIEW

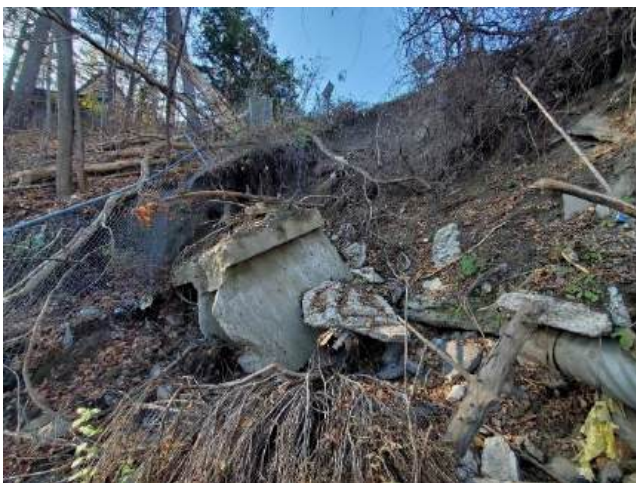
Outfall 27 has completely failed, with disconnected pipe segments and a concrete headwall strewn throughout the study area (**Figure 2-1** and **Figure 2-2**). Under current conditions, stormwater discharges from a failed 300 mm cast iron pipe protruding from the valley slope (**Figure 2-3**) approximately 27 m from the edge of the Muskrat River. Water exiting the pipe appears to have created a large scarp that has a maximum width of ~13 m and is characterized by steep slopes exceeding 1.4H:1V in some places. Large amounts of debris, including concrete rubble, sewer pipe segments, and woody debris are found within the scarp. Some of the concrete rubble found within the site appears to have belonged to a manhole and/or drop structure that may have helped stormwater overcome the steep vertical gradient before discharging into the Muskrat River (**Figure 2-4**).

Figure 2-1: Debris within the Study Area

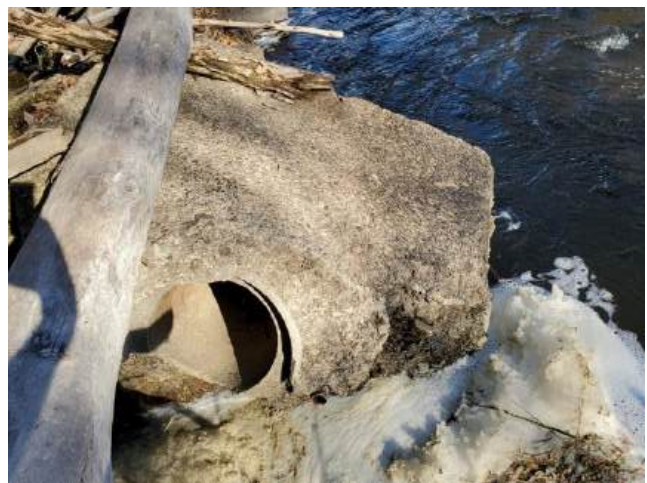
Figure 2-2: Failed Concrete Headwall and Pipe Segment

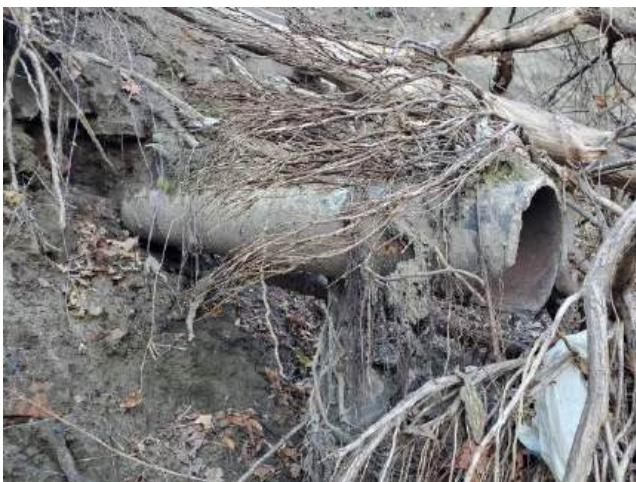
Figure 2-3: Remaining Pipe Protruding from the Slope

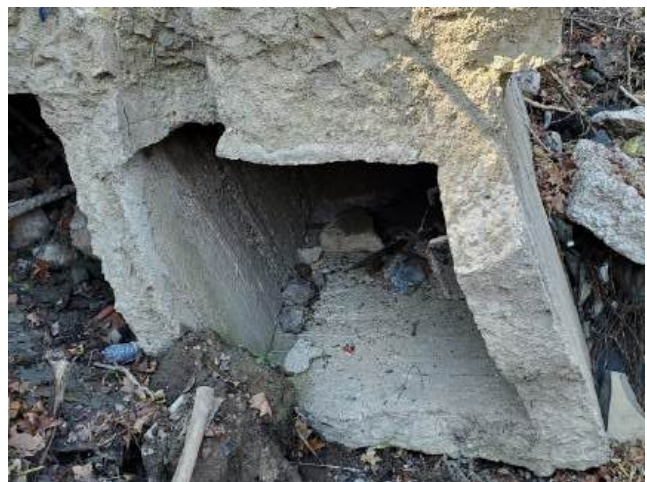
Figure 2-4: Possible Rubble from a Failed Manhole

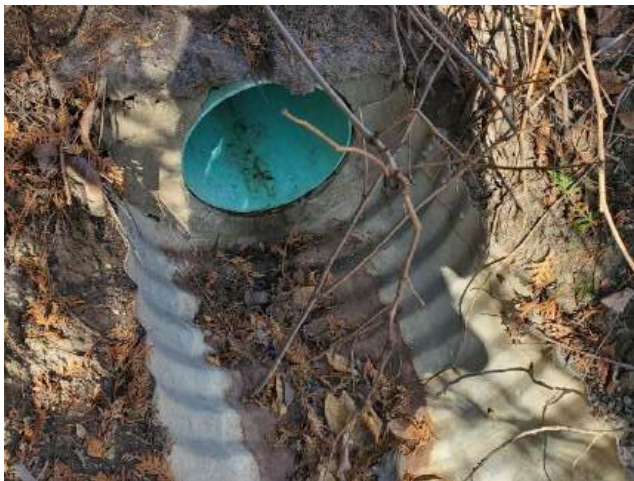
As can be seen in **Figure 2-1** and **Figure 2-2**, the existing outfall is composed of a 300 mm PVC pipe that discharges into a 525 mm CSP half-pipe extending past the bottom of bank and into the Indian River. The CSP is in poor condition, as one section downstream has been undermined, and another has become entirely detached (**Figure 2-3** and **Figure 2-4**). The CSP also displays evidence of rust corrosion, and bank erosion was noted beneath the pipe.

Figure 2-1: PVC Pipe Outlet into the CSV Half-Pipe

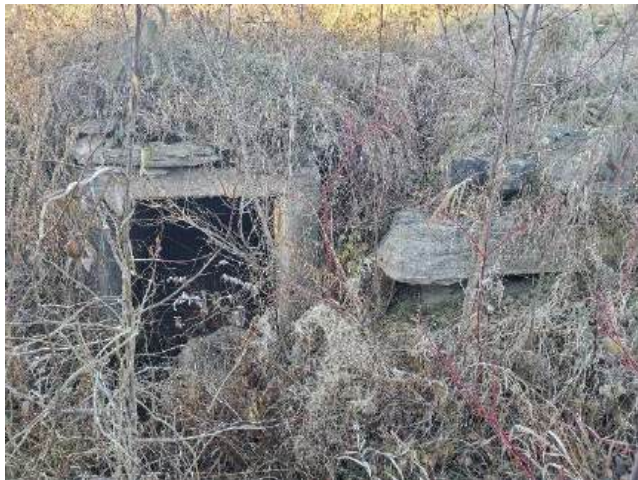
The assessment of Outfall 35 revealed that water is collected from upstream ditches by a concrete box culvert (Box Culvert #1, **Figure 2-1**) that is in fair condition and passes under a decommissioned asphalt road. On the downstream side of the road, it appears that both the box culvert and a ditch were intended to feed into a second concrete box culvert (Box Culvert #2, **Figure 2-2**), which is now severely deteriorated and segmented, causing water to flow around it. Water then passes into a series of disconnected 1050 mm concrete pipe segments (**Figure 2-3**), before discharging into a scour pool (**Figure 2-4**) that connects to the Muskrat River via a 20 m long outfall channel. Based on the observed existing conditions, it is unclear whether Box Culvert #2 and the concrete pipe were initially connected or simply joined by an open-air channel. Channel gradient is high throughout the study area, having an average of 10% between the outlet of Box Culvert 1 and the scour pool.

Figure 2-1: Box Culvert under the Asphalt Road (Box Culvert #1)

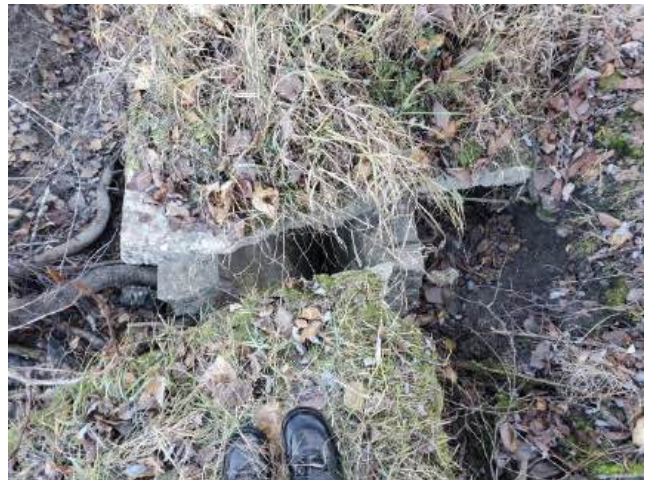
Figure 2-2: Failed Box Culvert (Box Culvert #2)

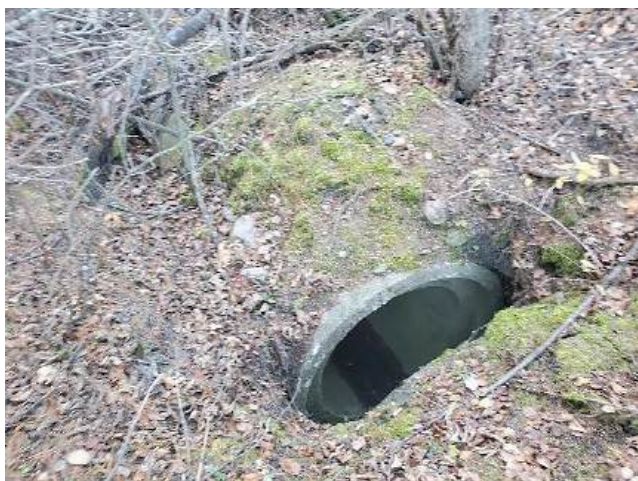
Figure 2-3: Concrete Pipe Segments

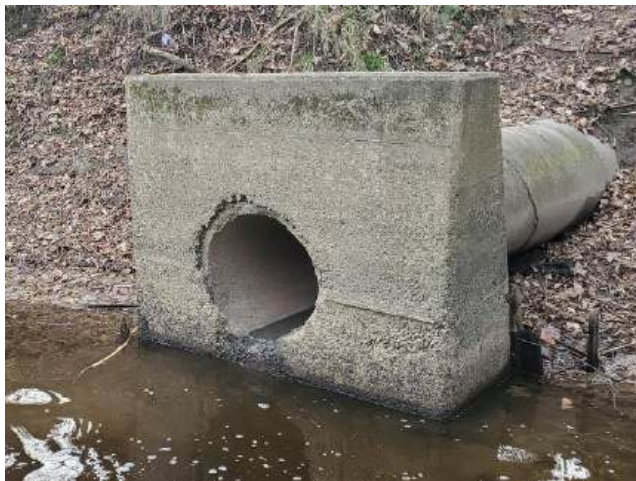
The assessment of Outfall 41 revealed that it has been outflanked and is in critical condition (**Figure 2-1** and **Figure 2-2**). The concrete headwall and 600 mm sewer pipe have been undermined, which appears to have caused settling of the outfall structure, thereby placing stress on the concrete pipe. Two points of failure were noted along the concrete pipes: a 1" wide crack along the exposed outlet pipe that was leaking water (**Figure 2-3**), and a 1" wide gap between two pipe segments (**Figure 2-4**).

Figure 2-1: Outflanked Outlet Pipe

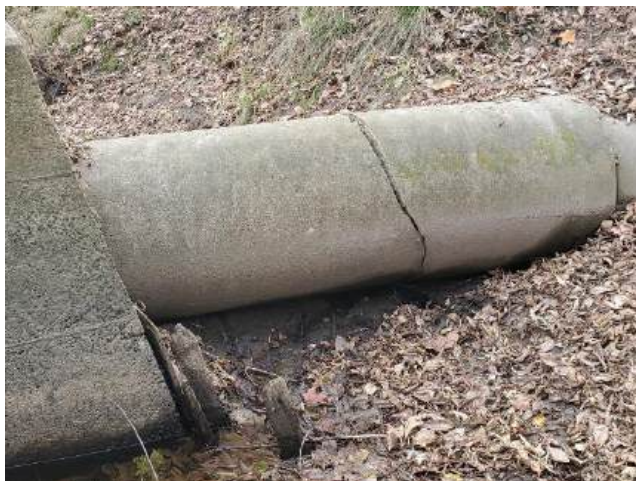
Figure 2-3: Cracked Concrete Pipe

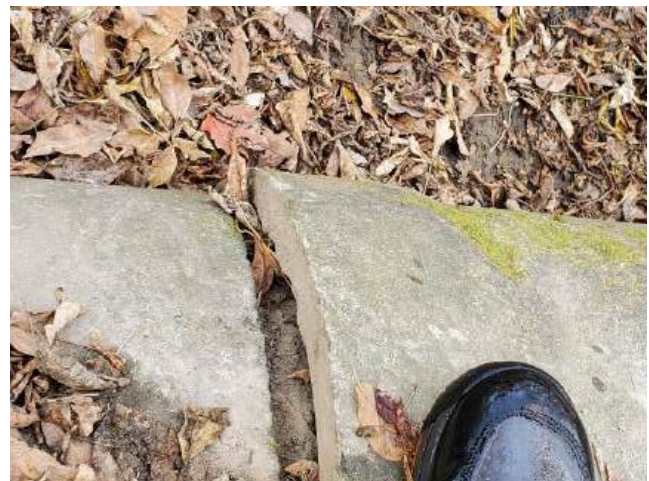
Figure 2-4: Disconnected Pipe Segments

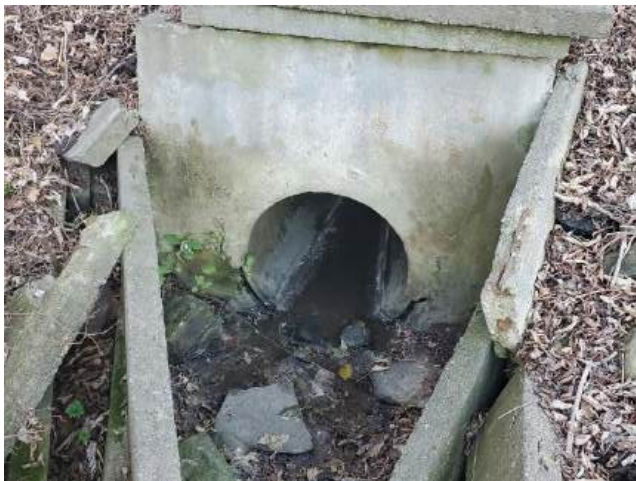
The existing outfall structure consists of a 600 mm concrete sewer pipe, a concrete headwall, and failed concrete wingwalls (**Figure 2-1**). The sewer pipe outlets into a 30 m long outfall channel (**Figure 2-2**), with substantial bank erosion and downcutting noted at the downstream extents of the channel (**Figure 2-3** and **Figure 2-4**). Channel gradient is very high throughout the study area, having an average of 19% between the outlet and the Indian River.

Figure 2-1: Concrete Pipe Outlet with Headwall and Failed Wingwalls

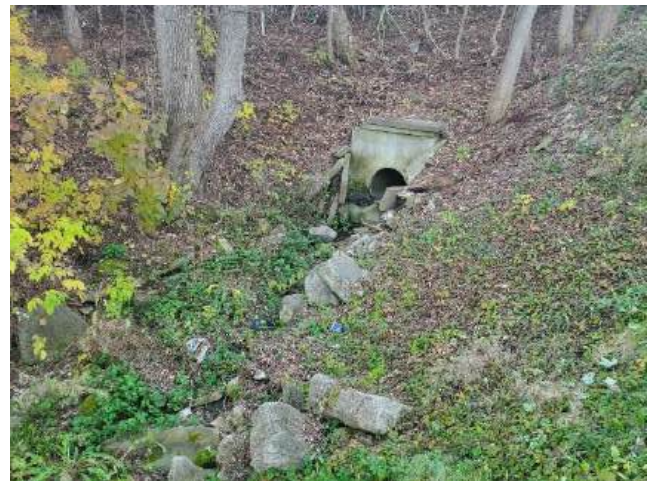
Figure 2-2: Outlet and Upstream Extents of the Outfall Channel

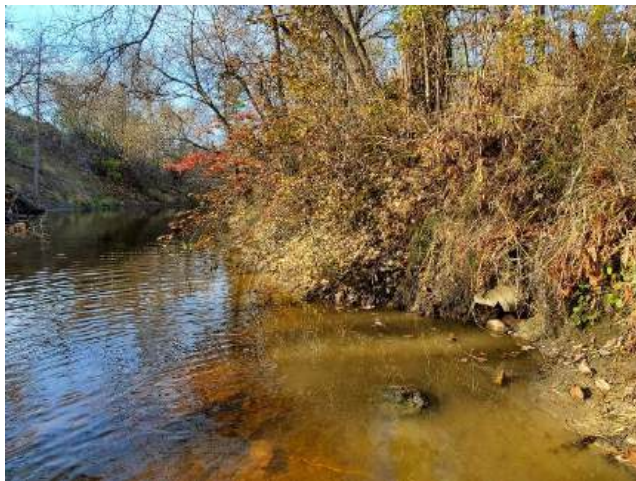
Outfall 45 consists of a 200 mm concrete sewer pipe that has failed at the downstream-most pipe joint, creating a 30 cm gap between the detached pipe segment and the upstream pipe (**Figure 2-1** and **Figure 2-2**). The concrete pipe upstream of the failed joint remains in good condition (**Figure 2-3**), though it is recessed into the channel bank, with scouring noted near the outlet (**Figure 2-4**). There is also evidence of bank erosion near the outfall (**Figure 2-1** and **Figure 2-2**), which has steeped the bank in this area and created a near-vertical slope.

Figure 2-1: Detached Concrete Pipe Segment

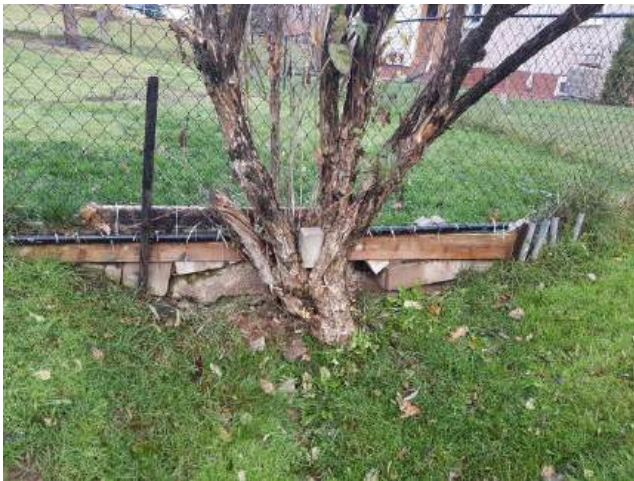
Figure 2-1: Upstream Collapsed Box Culvert

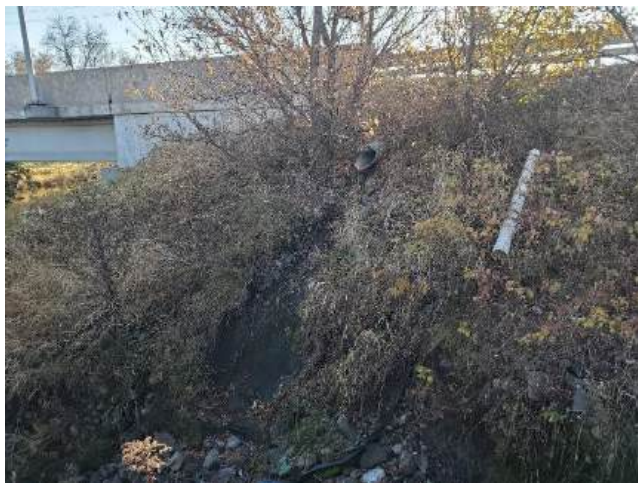
Figure 2-1: Outlet and Eroded Bank
