As part of the City-Wide Flood Risk Assessment and Storm Outlet Review, the City of Pembroke has requested an assessment of the condition on 17 of the City’s storm sewer outfalls, complete with an inventory of the findings. After conducting the outfall assessment, Aquafor Beech reported a total of 9 outfalls in poor condition and in need of repair. The following Technical Memo provides an overview of the existing conditions of Outfall 27 as well as the Detailed Design of the proposed outfall reconstruction.

CITY WIDE FLOOD RISK ASSESSMENT AND STORM OUTLET REVIEW

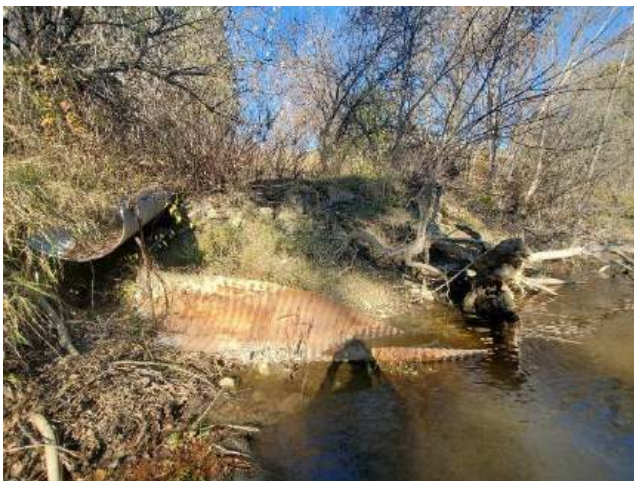
Figure 2-3: CSV Half-Pipe at the Edge of the Indian River (Looking Downstream)

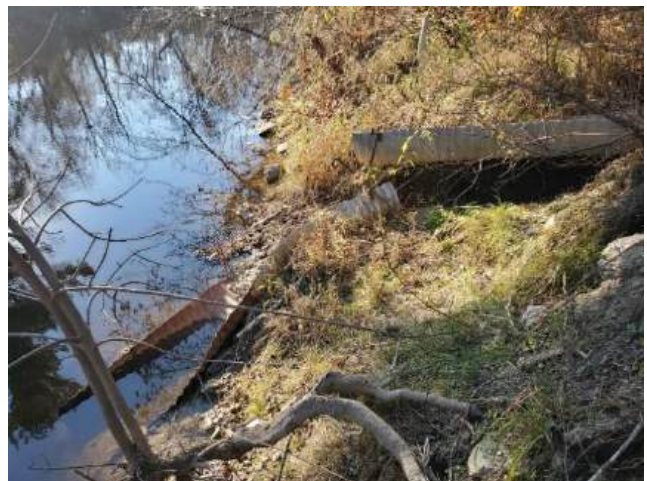
Figure 2-4: CSV Half-Pipe at the Edge of the Indian River (Looking Upstream)

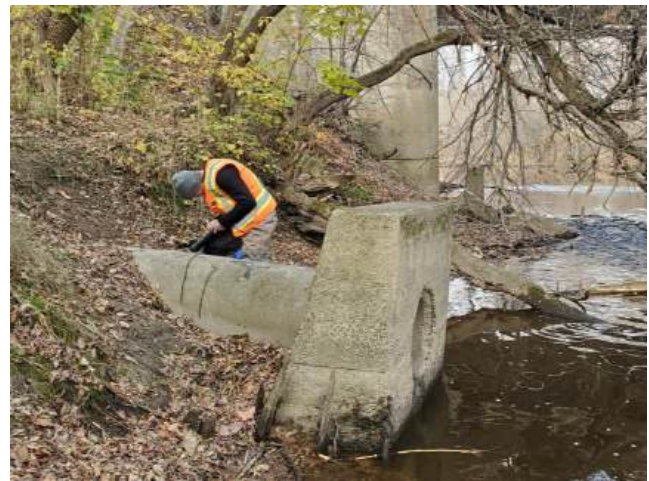
Figure 2-2: View of Outfall 41 Looking Downstream

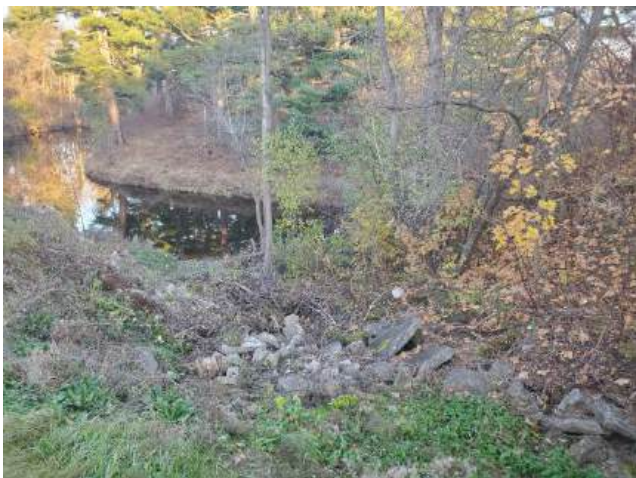
Figure 2-3: Erosion at the Downstream Extents of the Outfall Channel (Looking Downstream)

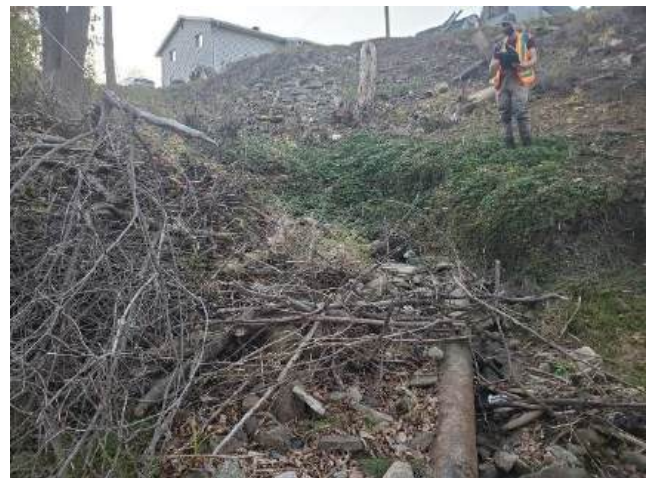
Figure 2-4: Erosion at the Downstream Extents of the Outfall Channel (Looking Upstream)

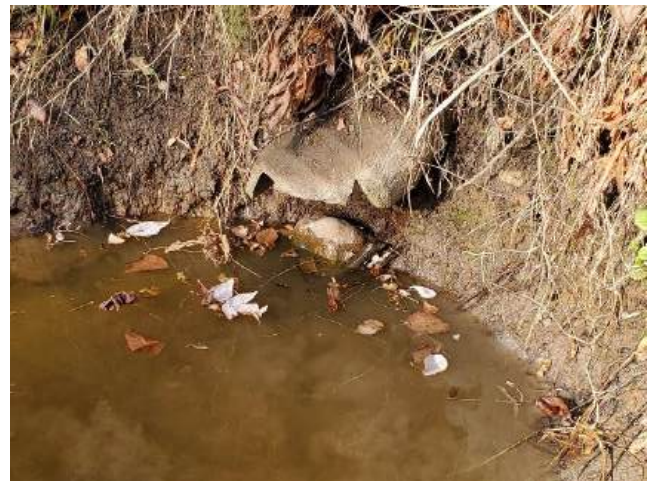
Figure 2-2: Close-up Photo of the Detached Concrete Pipe Segment

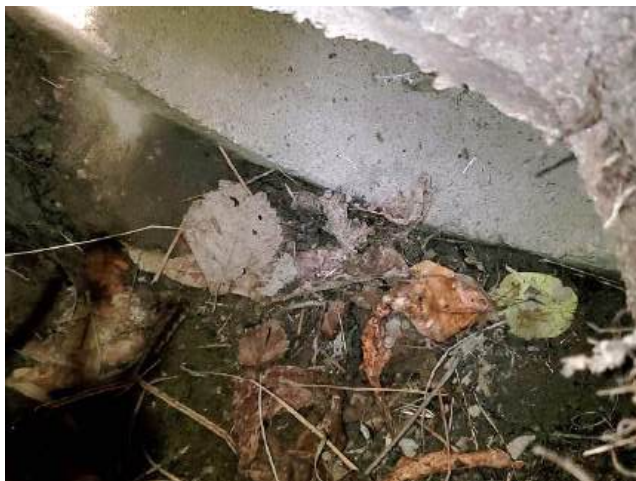
Figure 2-3: Close-up Photo of the Recessed Concrete Pipe Outlet

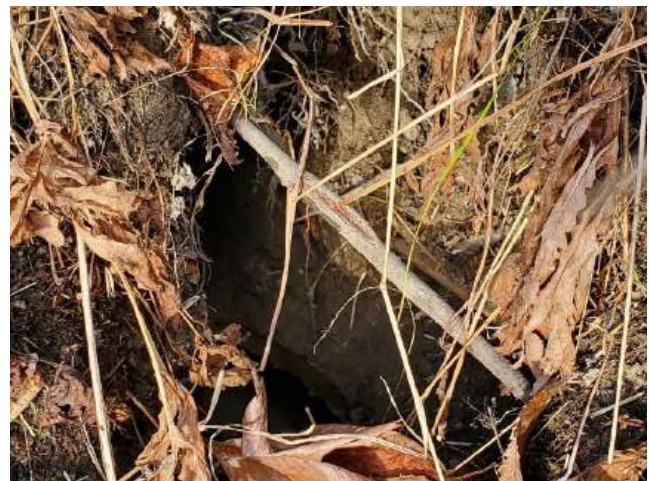
Figure 2-4: Scouring at Recessed Concrete Pipe Outlet

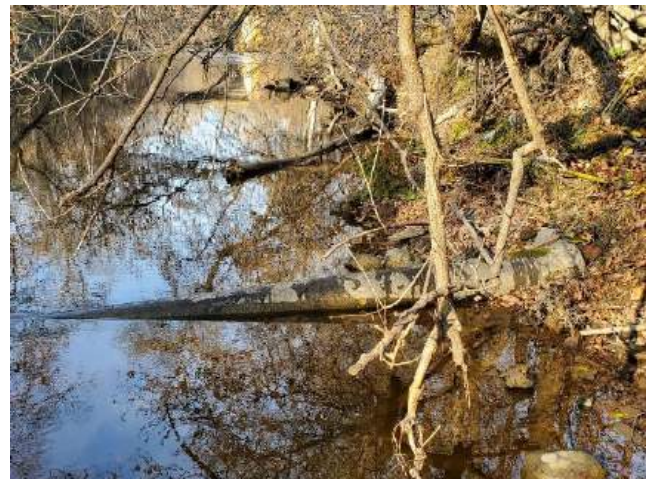
Figure 2-2: Cast Iron Pipe Extending into the Indian River (Looking Upstream)

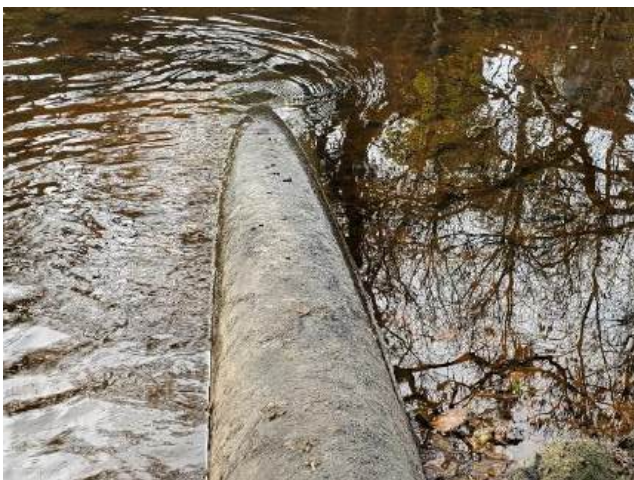
Figure 2-3: Close-up View of the Cast Iron Pipe

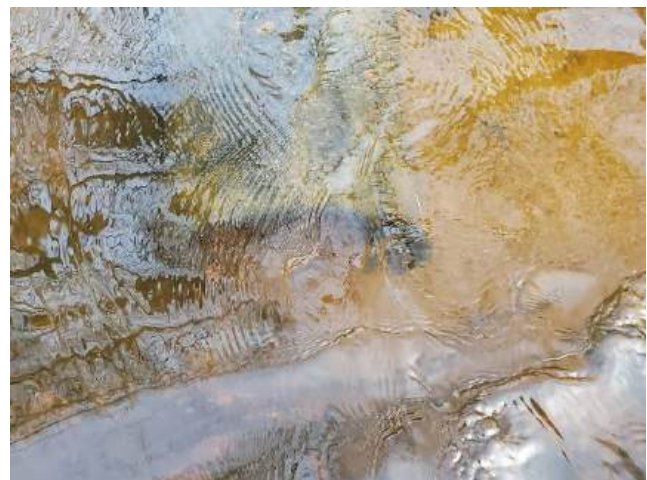
Figure 2-4: Submerged End of the Cast Iron Pipe

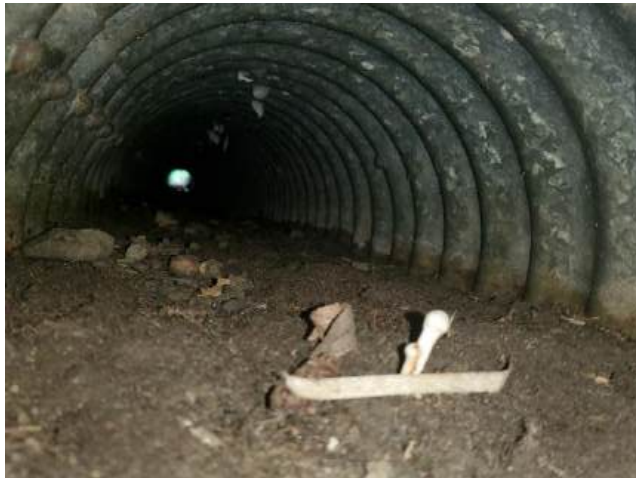
Figure 2-3: Sediment Deposits Inside the CSP

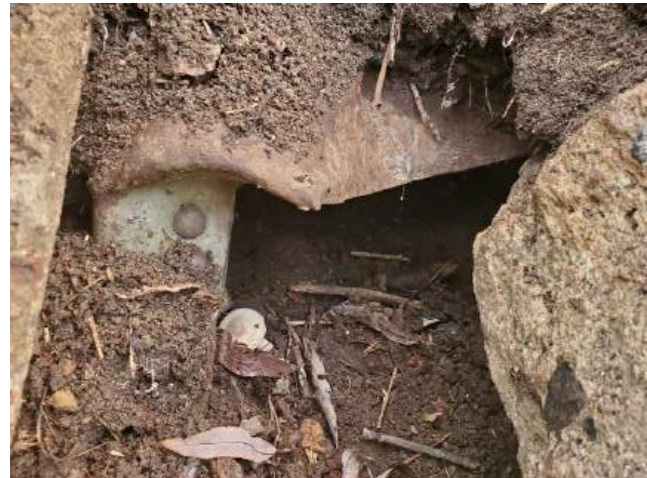
Figure 2-4: Crushed and Recessed CSP Outlet, Surrounded by Concrete Rubble

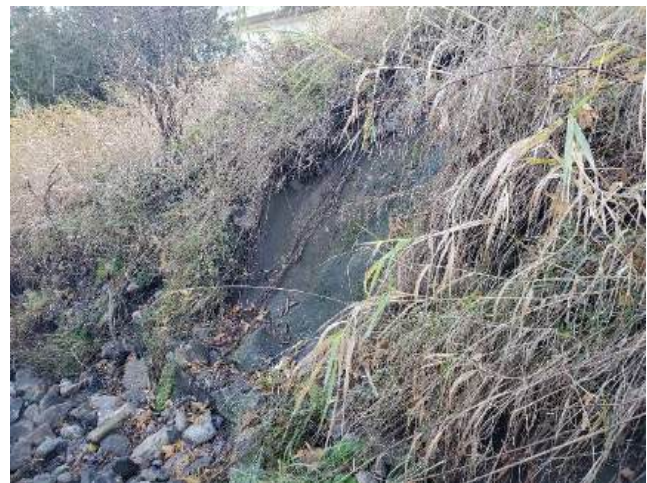
Figure 2-2: Eroded Bank at Outlet

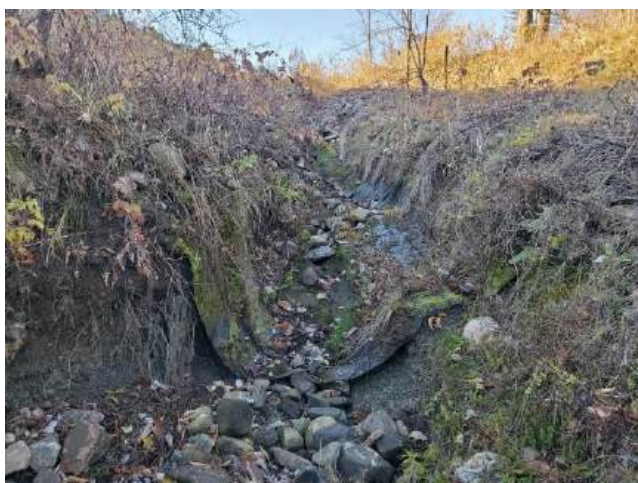
Figure 2-3: Bank Erosion and Exposed Geotextile

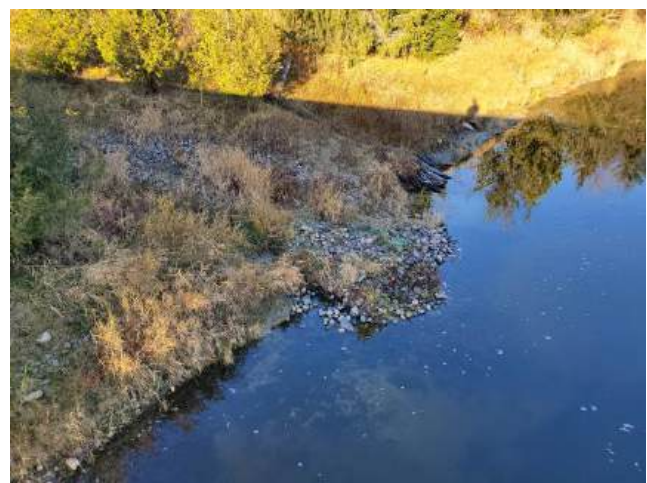
Figure 2-4: Washed Out Swale
