As part of the City-Wide Flood Risk Assessment and Storm Outlet Review, the City of Pembroke has requested an assessment of the condition on 17 of the City’s storm sewer outfalls, complete with an inventory of the findings. After conducting the outfall assessment, Aquafor Beech reported a total of 9 outfalls in poor condition and in need of repair. The following Technical Memo provides an overview of the existing conditions of Outfall 27 as well as the Detailed Design of the proposed outfall reconstruction.

CITY WIDE FLOOD RISK ASSESSMENT AND STORM OUTLET REVIEW

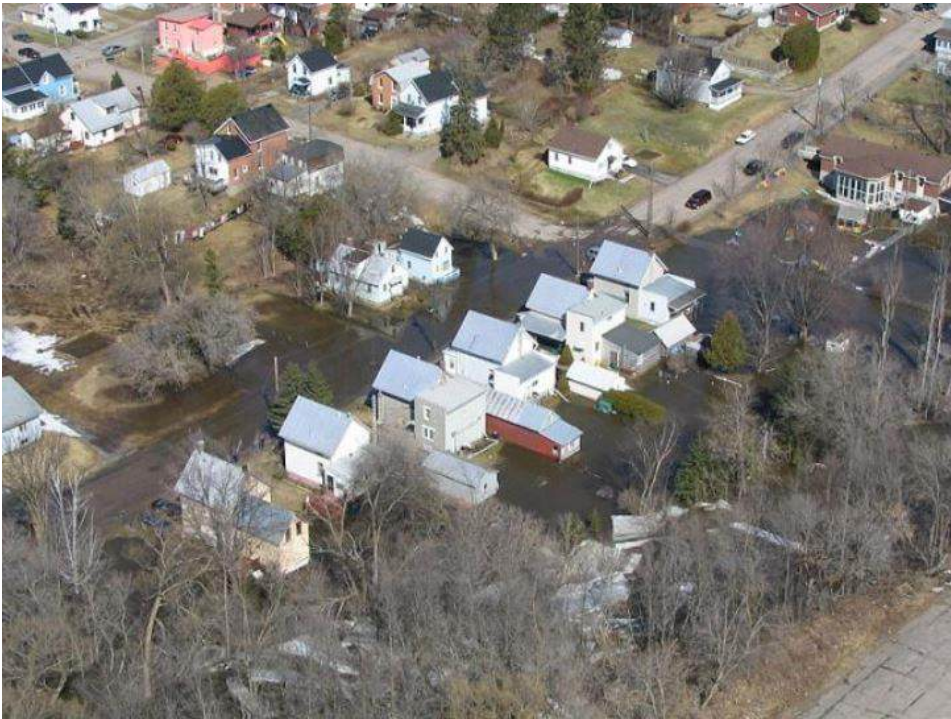
2003 Doran Street and D'Arcy Street Intersection

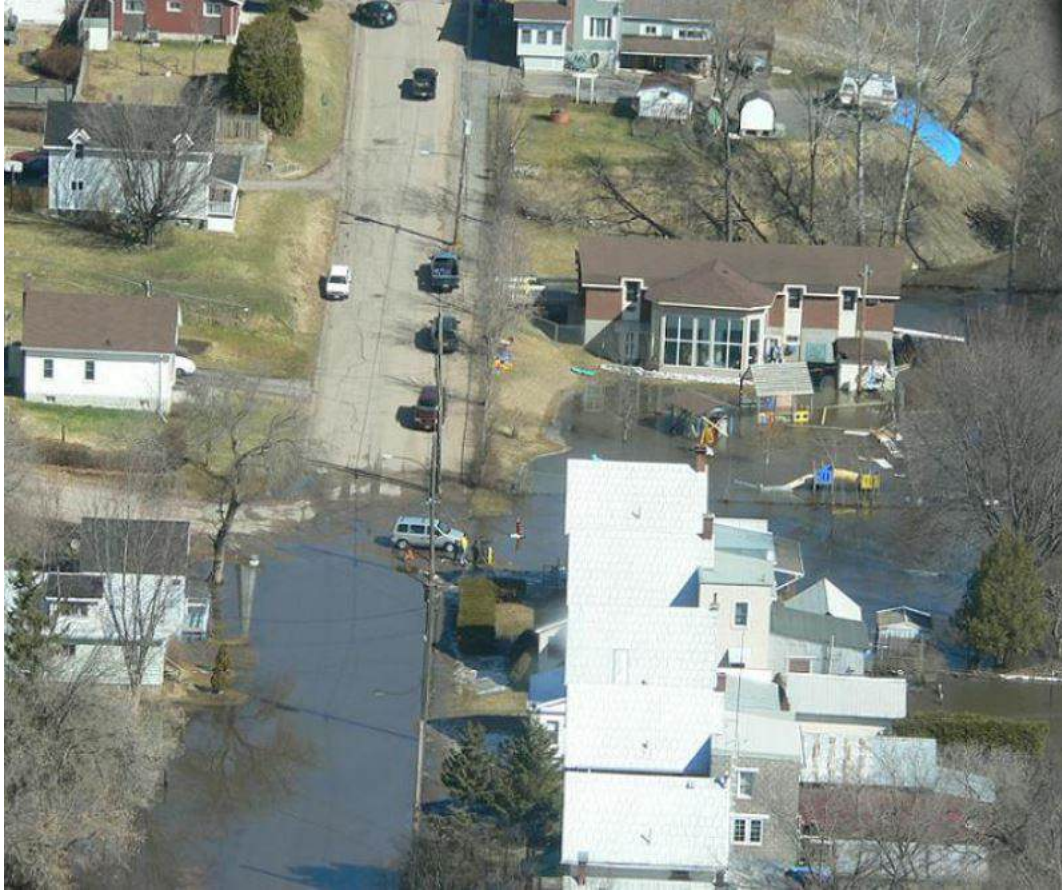
2003 Doran Street and D'Arcy Street Intersection

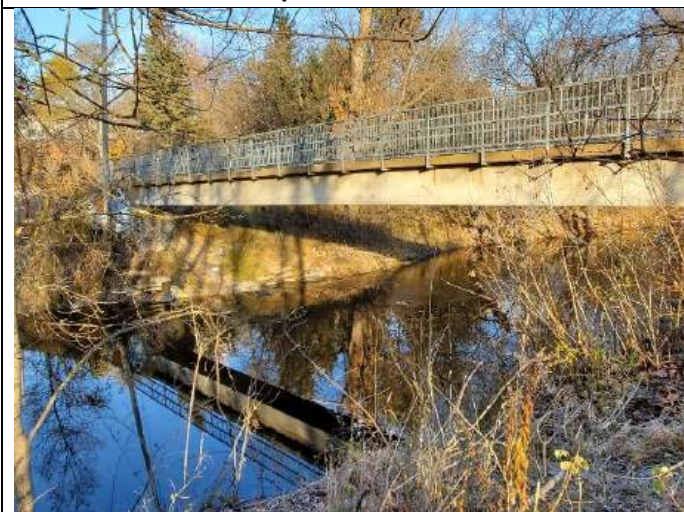
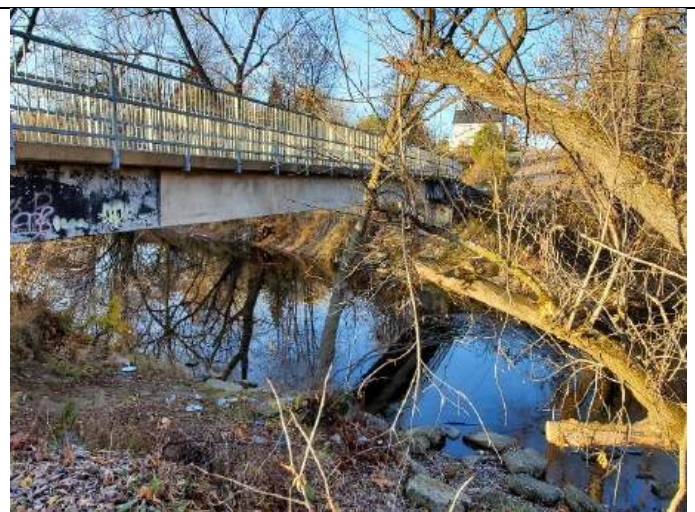
Small wingwalls present on both U/S and D/S of bridge, and on both right and left sides

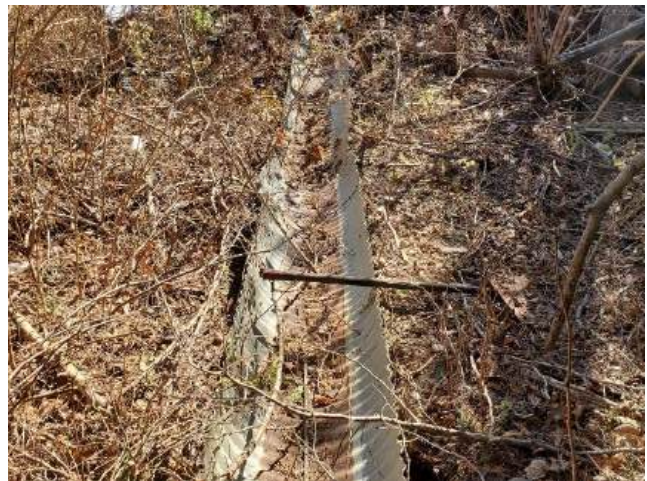
Figure 2-2: CSV Half-Pipe

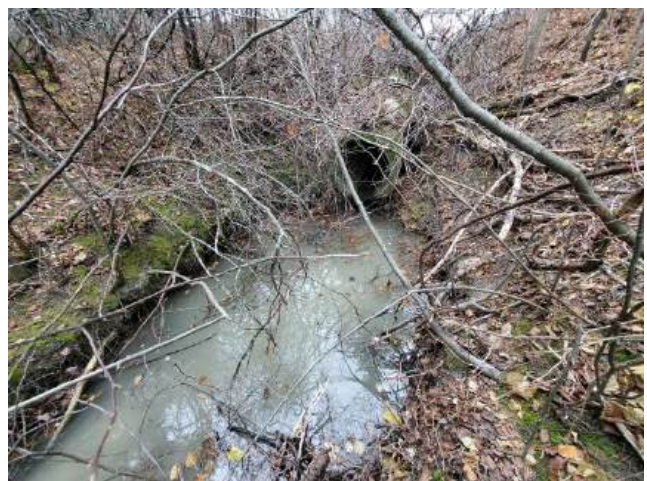
Figure 2-4: Scour Pool
